Archaeological Building investigation

Vallis Salutis a Cistercian Abbey at Baltinglass, County Wicklow, Ireland

written by
SIMON HAYTER
January 2015

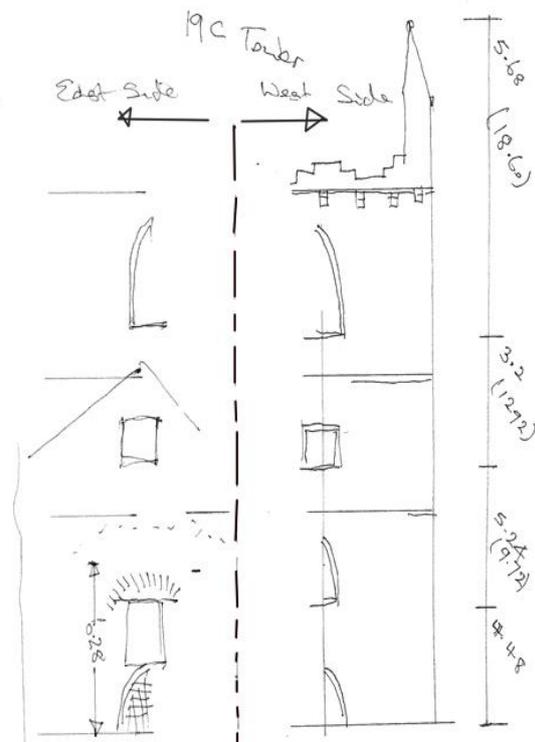
Figure 3: Structural Survey sketch

Each context was recorded, see Appendix VII, and measured using a Bosch 40m Laser Rangefinder and a horizontal datum was established using both a Mannesmann Laser Spirit Level and a Mannesmann Rotating Laser. Photographs were taken with a Nikon D800 Digital SLR with a GP-1A GPS Unit and Nikon 24-70mm and 70-200mm f/2.8G Prime lens. The images were processed using Adobe Photoshop CS3, with a Graphic Tablet. The elevations were initially sketched (Figure 3), to determine where detail or measurements were missing, and then converted into architectural drawings using Autodesk’s AutoCAD 2014 (Student License) and the horizontal sequence was drawn using Microsoft Visio 2013. This report has been written using ClfA guidelines (2008:16-18).

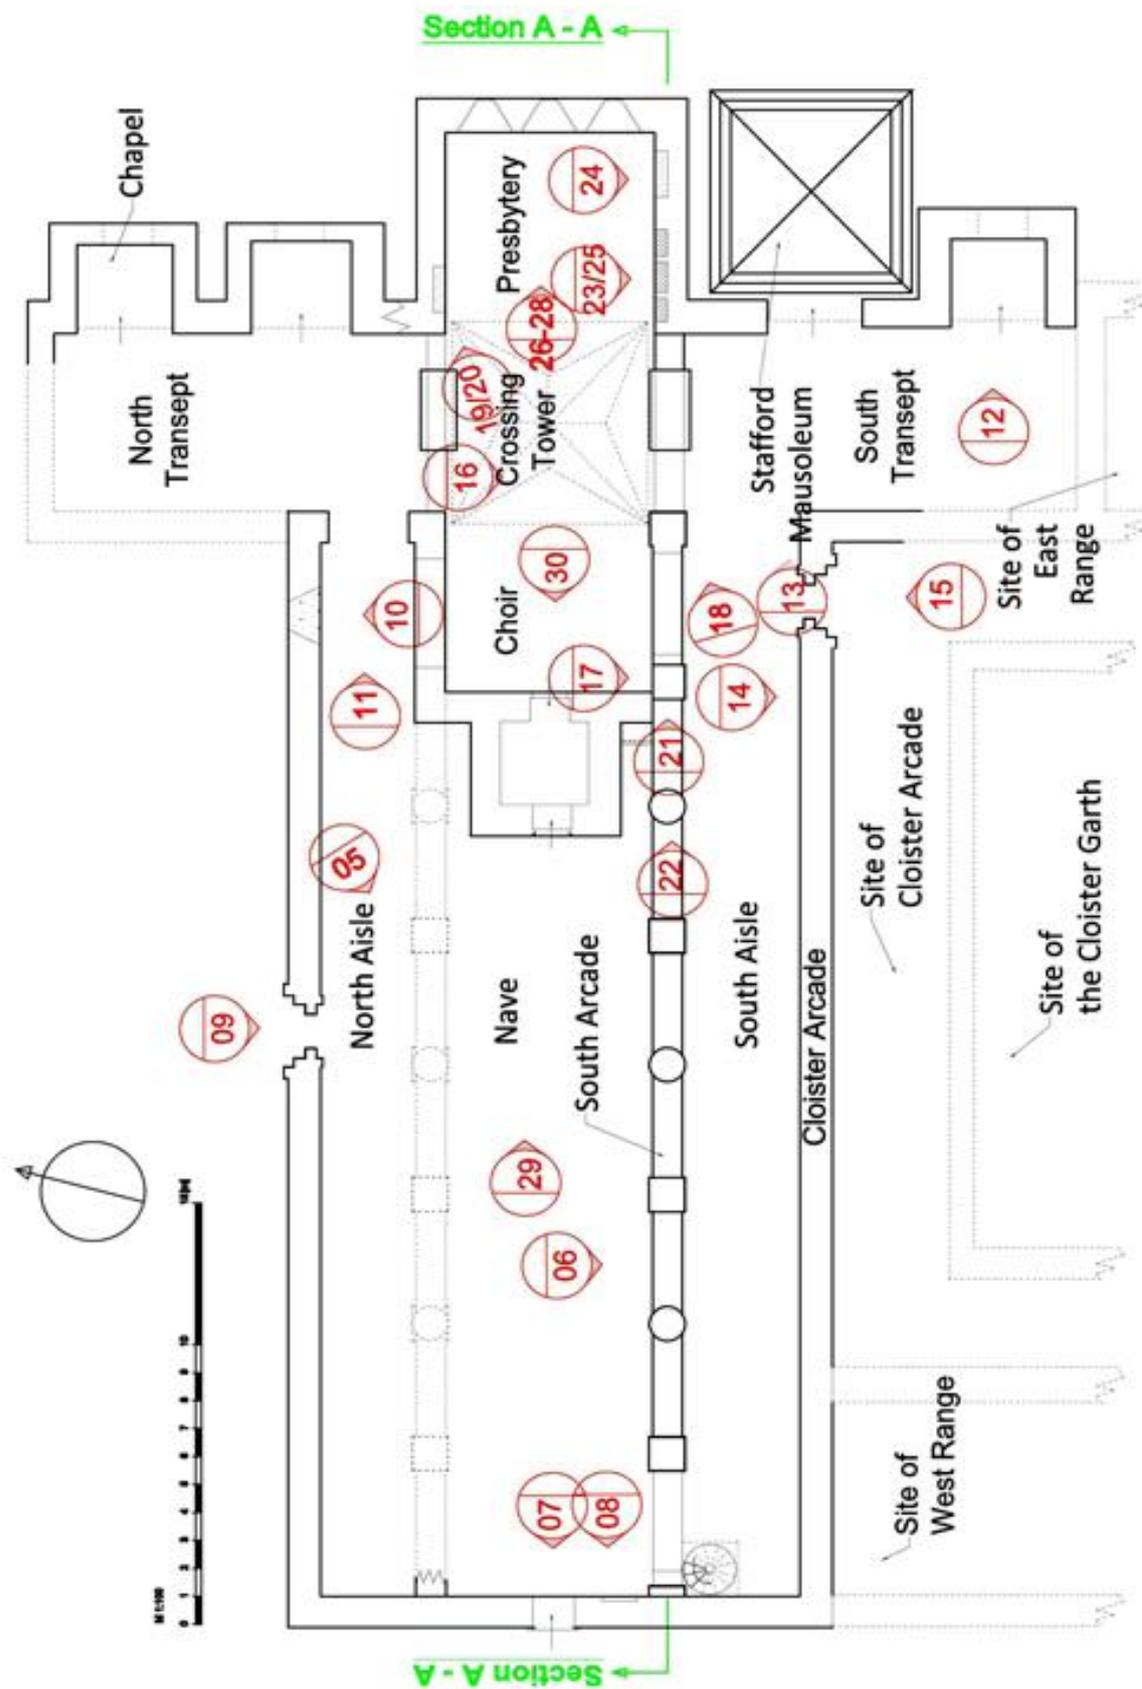
Figure 4: Site Overview and image locations (shown in red)

The church, Context-1, is the only surviving standing building from the Baltinglass Abbey (Figure 4). It comprises the presbytery, crossing tower and choir, transepts and chapels and a nave with its southern aisle which is divided by an arcade with arches. Most of the structure was built of uncoursed granite rubble which would have been plastered and whitewashed with slaked lime (so the rubble was not visible). Its arches, windows and doorways were formed from granite ashlar quoins.

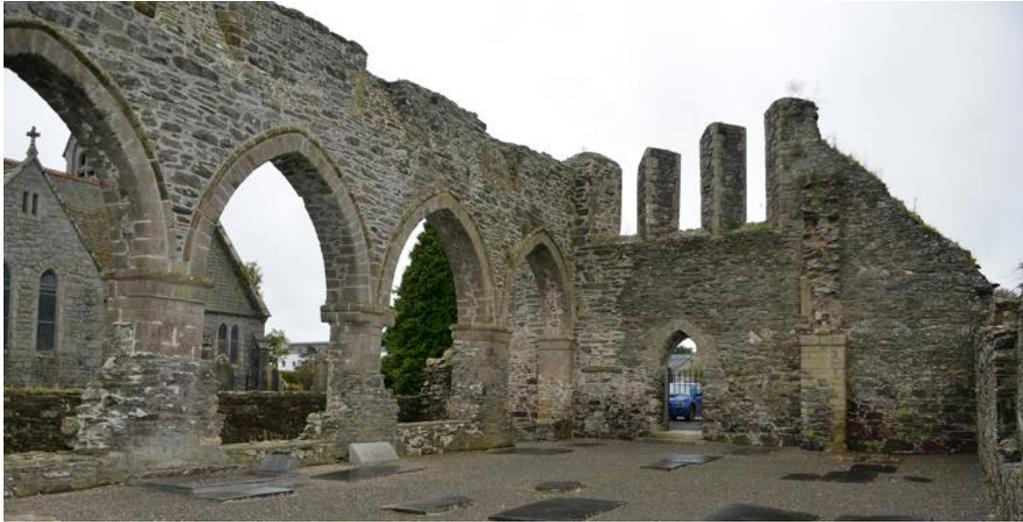
Figure 5: *South-West aspect of the Nave*

Today the nave, Context-2 through 20, is a large and open space, approximately 31.5 meters long and 7.1 meters wide, with the remains of an arcade and aisle (Figure 5).

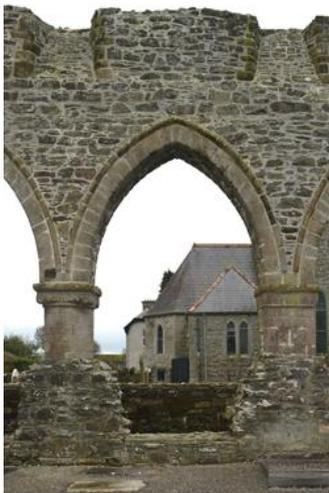
Figure 6: *Context-12 (Arch)*

The nave's west wall, Context-12, is 10.0 meters high and it is the tallest surviving section of the building. It has a lancet window with three lights; the lower parts of the windows have subsided approximately 10 degrees inwards, Context-13. The west door, Context-14 (Figure 7) is constructed from granite blocks with visible flecks of mica. Grogan and Hillery (1993:39) suggest that it dates from the fifteenth century, but Grose's drawing shows a rectangular doorway and, because the neo-gothic tower's doorway is very similar, I feel confident in assigning it to the nineteenth century rebuilding phase. The foundations of the north aisle and its pilaster are visible, Context-15. A blocked feature is visible between the door and south arcade, Context-16 (Figure 8) which possibly held a Piscina for use by lay-brothers (there is a similar niche in the presbytery).

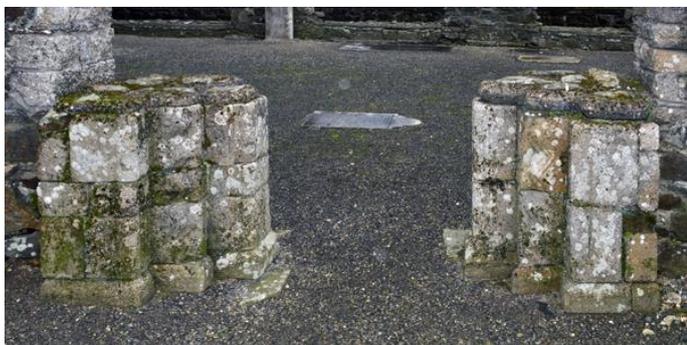
Figure 9: Context-18 (North Wall)

The nave's north wall, Context-17, has been reconstructed and a twentieth century excavation revealed a decorative doorway at its centre (excavation report was not produced (NMA 2015, pers. comm. 05-Jan-2015)). The doorway, Context-18 (Figure 9), gave access from the exterior into the north aisle; Grogan and Hillery (1993:39) wrote that this is unusual for Cistercian churches but visits to the Cistercian Abbeys at Jerpoint and Dunbrody confirm that both of these buildings have similar features. The doorway's lower section is stylistically Early Gothic and it has three deeply recessed pillars, which are carved with either a dogtooth or a vertical quirk moulding, and the surviving element of the middle section jambs have triple base/pilasters. The doorway was probably topped with a semi-circular tympana. The doorway's design seems at odds with the Cistercian's austere designs, but O'Keefe (1997:69) points out that the style is used in other mid-twelfth century Irish Romanesque religious buildings, so this may be related to the master mason rather than a relaxation of Cistercian standards.

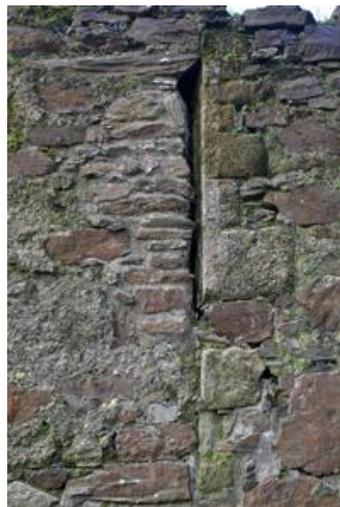
Figure 10: *Context-19*
(Blocked Window)

The nave's north wall has a blocked window, Context-19 (Figure 10). The window is bounded by quoins which are stylistically similar to those in the presbytery so it may date from the twelfth or thirteenth centuries. It is blocked with uncoursed granite rubble, but there are distinct gaps around its edge. A gothic arch, 4.9 meter high and 2.7 meters wide, Context-20 (Figure 11), is at the western end of the north aisle; it demarks the nave and the northern transept. Its impost, like the arches which support the south aisle, are intricately carved with foliate designs.

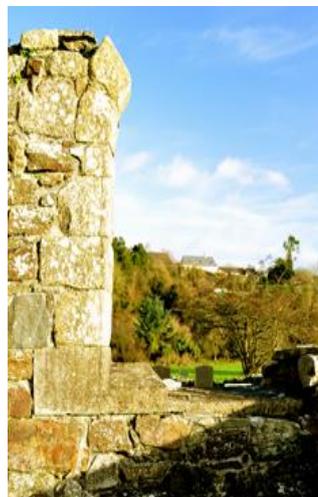
Figure 12: *Context-23*
(Chapel Window)

The south transept's right most chapel has part of its window frame *in situ*, Context-23 (Figure-12). The window has a two-pointed arch rising from a sill and the jambs are decorated with a quirk. The south transept's left most chapel has been reused for a mausoleum, Context-25 (Figure 13). The pyramidal structure was constructed in 1839 as a burial place for the family of the Earl of Aldborough (Library Ireland 2013). It is 6.9 meters wide, 7.3 meters deep and 7.3

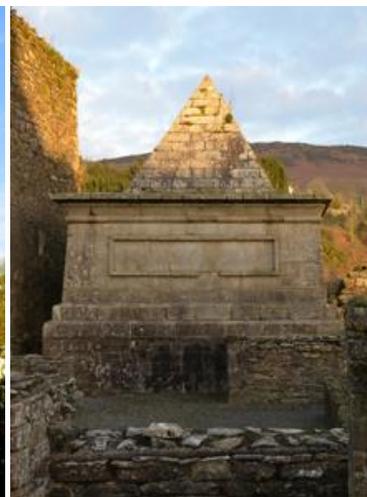
Figure 13: *Context-25*
(Stafford Mausoleum)

meters high. There is an entrance on the mausoleum's north side and, like the plaque on its front, is empty.

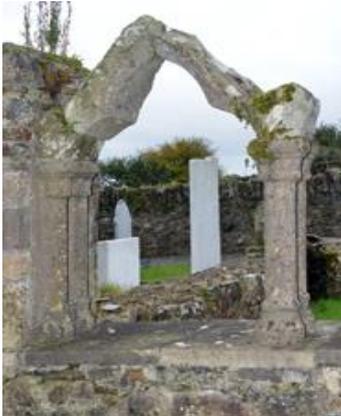
Figure 14: Context-26
(Cloister Arcade)

The Cloister, which played a central role in the daily-life of the Cistercian monks, only has two partly surviving sections. A fragment of the cloister arcade, Context-26 (Figure 14), has been reconstructed. The colonettes, which are contemporary and formed from concrete, support a trefoiled archivolt. Its location is not its original position; it is placed on the footing of the southern aisle but cloister arcades, which were formed by a series of low arches, were intended to be beyond the cloister gallery. The doorway between the cloister and claustral range, Context-27 (Figure 15), has been reconstructed from excavated blocks. The lower section is similar to the north doorway, but it has a much simpler form with two recessed pillars which are decorated with a thin quirk. The cloister, including its doorway and arcade, would have been part of the abbey's later building phases and Stalley (1987:155) has dated the trefoiled arch to the beginning of the fourteenth century.

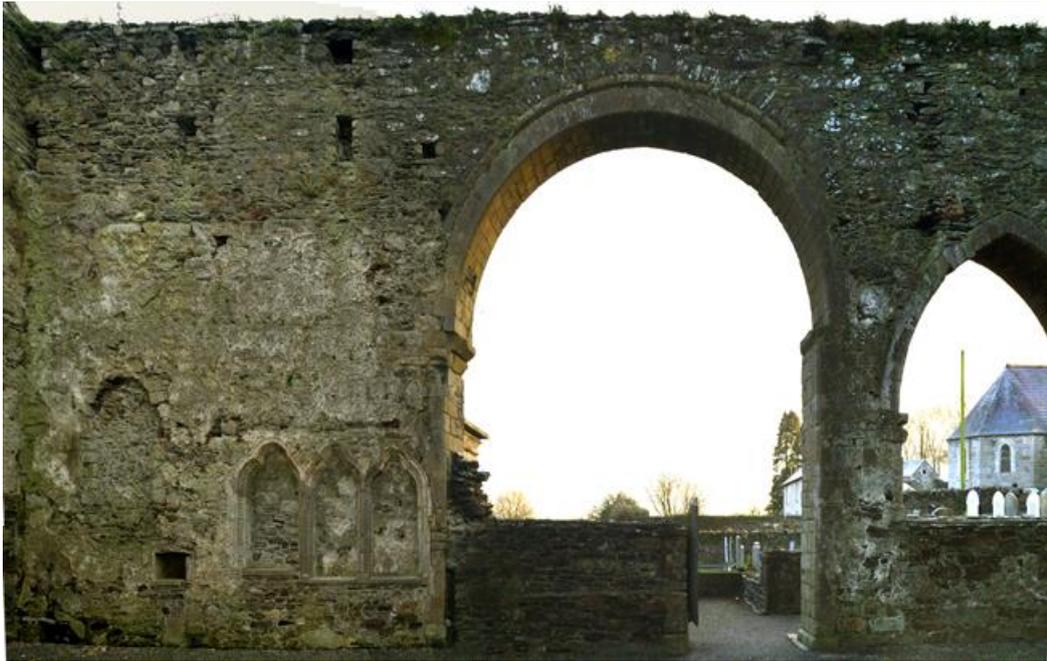
Figure 16: *Context-32 (South Wall of Presbytery)*

The south wall, Context-32 (Figure 16) - produced using digital rectified images - is 20.2 meters wide and 8.5 meters high. It has small areas of concrete cladding, but most of the wall is original. The wall's arcade of arches has been bisected by the inserted west wall, Context-46 (Figure 17); it is unbonded and its construction is of a much lower quality than the previous building phases.

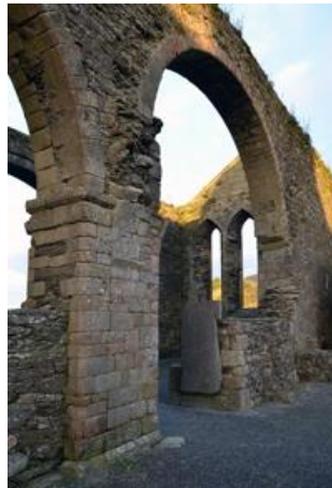
Figure 18: *Context-34 (pillar supporting arch)*

The most prominent feature is the substantial Romanesque arch, Context-35, which spans the space between the choir and the presbytery giving access to the transepts (a very similar arch is extant in the north wall). It is a stilted arch and is 7.8 meter high and 6.4 meters wide and it rises, on its right side, from a substantial pillar which is wider than the other arcade pillars, Context-34 (Figure 18) and on the left side by a column, Context-36 (Figure 19). The pillar's exterior has the stub of an arch, which would have demarked the transition from the nave into the southern transept (see Context-20 for the arch in the north transept). Its base is bulbous and has carved panels with either a floral design, spirals or what O'Keeffe (1997:73) believes is a lion (Figure 20; the column from north wall because south wall's column is obscured).

The structural unit formed by the pillar, column and the arch were clearly altered after the presbytery and nave arcades building phases. The column seems to be unaltered, but the pillar has been constructed from reused blocks and, curiously, the arch does not sit centrally over the pillar and the column. The rebuilding included the next westward arcade pillar; its rebuilding is confirmed by one section of the imposts having been reassembled in its original position, but upside down (Figure 21, highlighted in red). There does not seem to be any dating evidence for this rebuilding phase, but, as its style seems most similar to the first building phase I will, tentatively, determine that it was rebuilt shortly after the twelfth century.

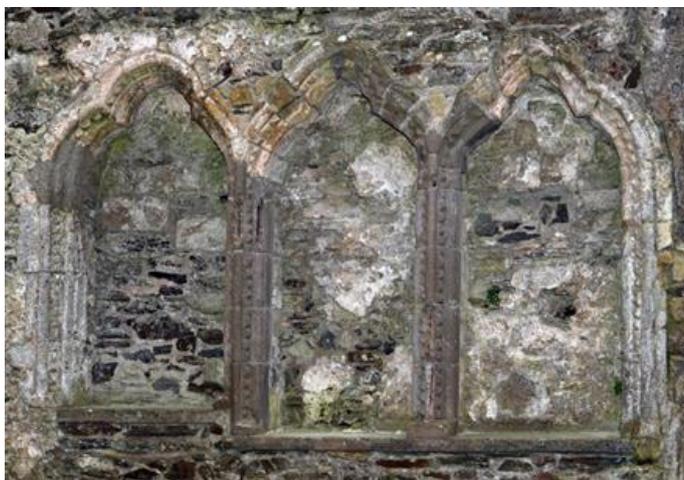
Figure 23: Context-37 (Sedilia)

The recessed Sedilia, Context-37 (Figure 23), which is 3.1 meters wide, has three granite seats; the seat closest to the altar was intended for the abbot and it is higher above the ground level than the other seats. The trefoil arches are flanked by narrow ogee moldings which are decorated with a series of pyramids and its overall design is common to many of the Irish Cistercian churches. Sections of the molding were repaired using concrete strengthened with an internal iron-reinforcing bar (see the darker sections on Figure 23). This repair has been less than successful, and the iron, now heavily corroded, has been exposed in some areas (Figure 25). Iron-reinforcing was reinvented during the nineteenth century (Russwurm 2003:3) and it is reasonable to conclude that it dates from that period.

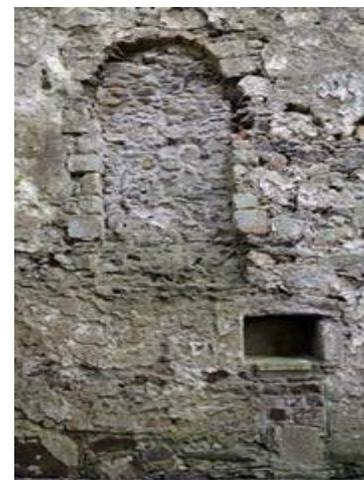
Figure 24: Context-38 and 39 (Piscina and window)

To the east of the Sedilia is a low Piscina, Context-38 (Figure 24), which is 1.2 meters wide and 0.5 meters high; its base has a scalloped indentation which held holy water used during a mass. Above it, offset to the east, is a blocked window with a rounded top, Context 39 (Figure 24), 2.3 meters high and 0.9 meters wide. It is filled with small uncoursed granite rubble, which is laid irregularly, and the rounded arch is formed from both dressed granite blocks and bricks. There is a second blocked window, on the north wall and further from the east wall, with a similar size, but without the rounded top.

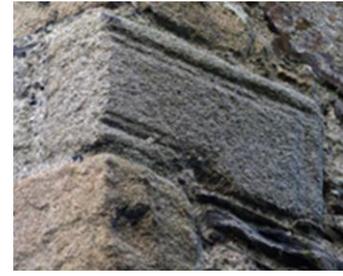
Figure 26: Context-42 (Reused block)

confirmed that they originated elsewhere, Context-42 (Figure 26) - they have the appearance of a shallow block from the lower part of a jamb decorated with a narrow quirk.

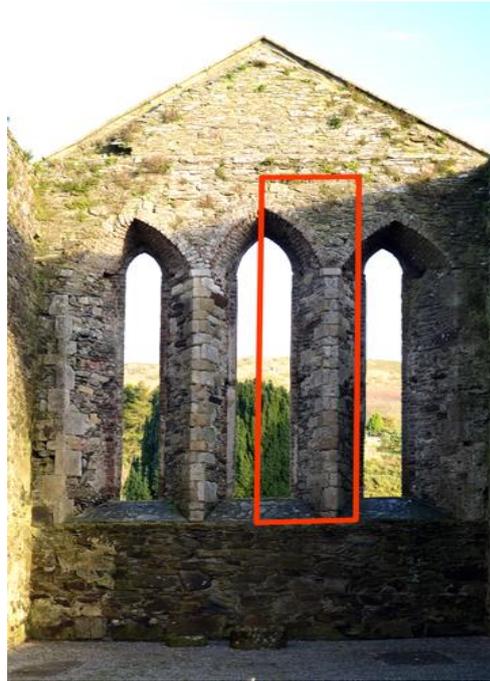
Figure 27: Context-40 (East Wall)

The original east wall, probably, had three low Romanesque windows, but it is evident that the whole wall was rebuilt, Context-40 (Figure 27) - probably during the 1810s when the space was converted into a Protestant parish church. The rebuilt wall, which is not fully bonded to the south wall is 12.4 meters, at its highest point, and 7.3 meters wide and it has three tall lancet windows (Context-41). The wall was rebuilt from uncoursed granite rubble and blocks, but the windows have been formed using bricks and the wall was bonded, and partially clad, using cement - materials that were not available in the twelfth century. See Figure 28 for the placement of bricks and cement in one subsection of the wall. Cement was not commonly used in Ireland until the nineteenth century (ICS 2014) and before this lime was used to make mortar (English Heritage 2011). At least two of the blocks were carved decoratively which

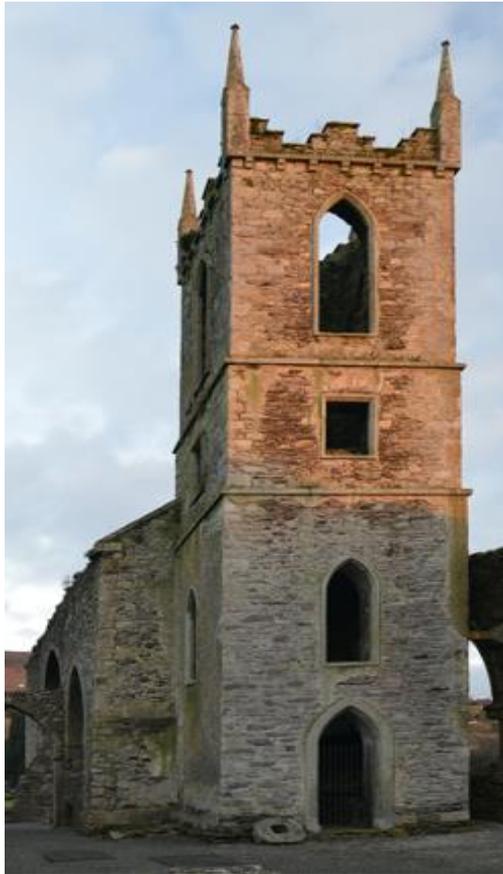
Figure 29: Context-52 (Bell Tower)

In the early nineteenth century, the presbytery, crossing tower and choir were converted into the local Protestant parish church, with a new Neo-Gothic bell tower, Context-52 through 58 (Figure 29, west exterior and Figure 30, interior).

The tower was constructed of reused uncoursed rubble with granite ashlar quoins; it is 18.6 meter high and, at its base, 5.2 meters wide (its internal space is 3 meters square but it was not possible to determine its height). It has three stepped sections, each slightly smaller than the section below. The distinct sections and windows were formed by pre-manufactured slabs and it is topped with a mock-crenellated parapet. Both the exterior and interior were clad with cement (much of which has now been removed). The tower is stylistically similar to a number of other towers in the Baltinglass including a modest structure in the Catholic graveyard (Figure 31, left) and a more ornate structure which is integral to Saint Joseph's Church (Figure 31, right).

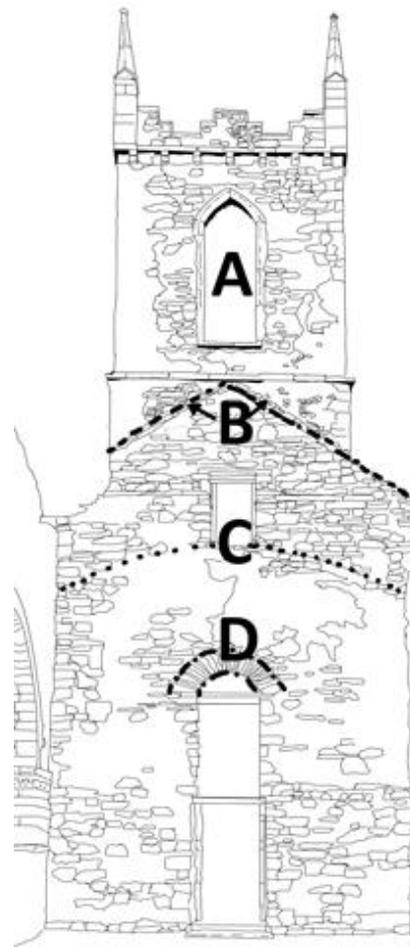
Figure 32: Tower features

Its east-most wall was added over the apex of Context-46 (Figure 32.A). The structure's roof line can be determined from the earthenware tiles which probably directed rain

into lead flashed channels (Figure 32.B). A curved layer of blocks, (Figure 32.C), which have evidence of painted plaster, must have formed part of the parish church's internal features (possibly a gallery above its nave). The presbytery's inserted west wall and a crudely formed doorway/window (Figure 32.D) have been fashioned by reusing the "lofty plain east window", described by Daniel Grose (Appendix IV.A).

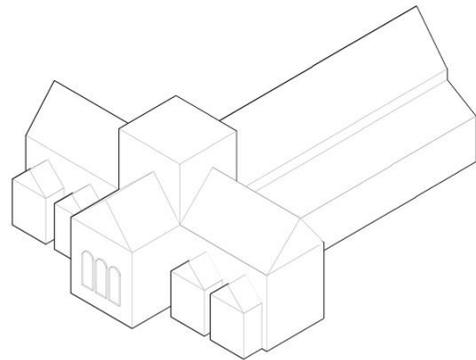
Figure 33: *Building Phase 1*

The first major phase of building, see Figure 33, can be relatively well understood from the standing buildings – which is supported by the corpus of studies on Cistercian Abbeys. The initial building phase began in the mid twelfth century and, as with all Cistercian establishments, included an oratory (i.e. presbytery/choir) and conventual buildings such as the dormitory, refectory and guest quarters (Burton and Kerr 2011:54-65). Very little of the transepts or their chapels survive for comparison, but it is probable that they were built at the same time as the presbytery/choir during a single multi-decade building phase. They were built using a style that Stalley (1987:79-80) described as 'Burgundian' and which included the protruding chapels and wide Romanesque arches.

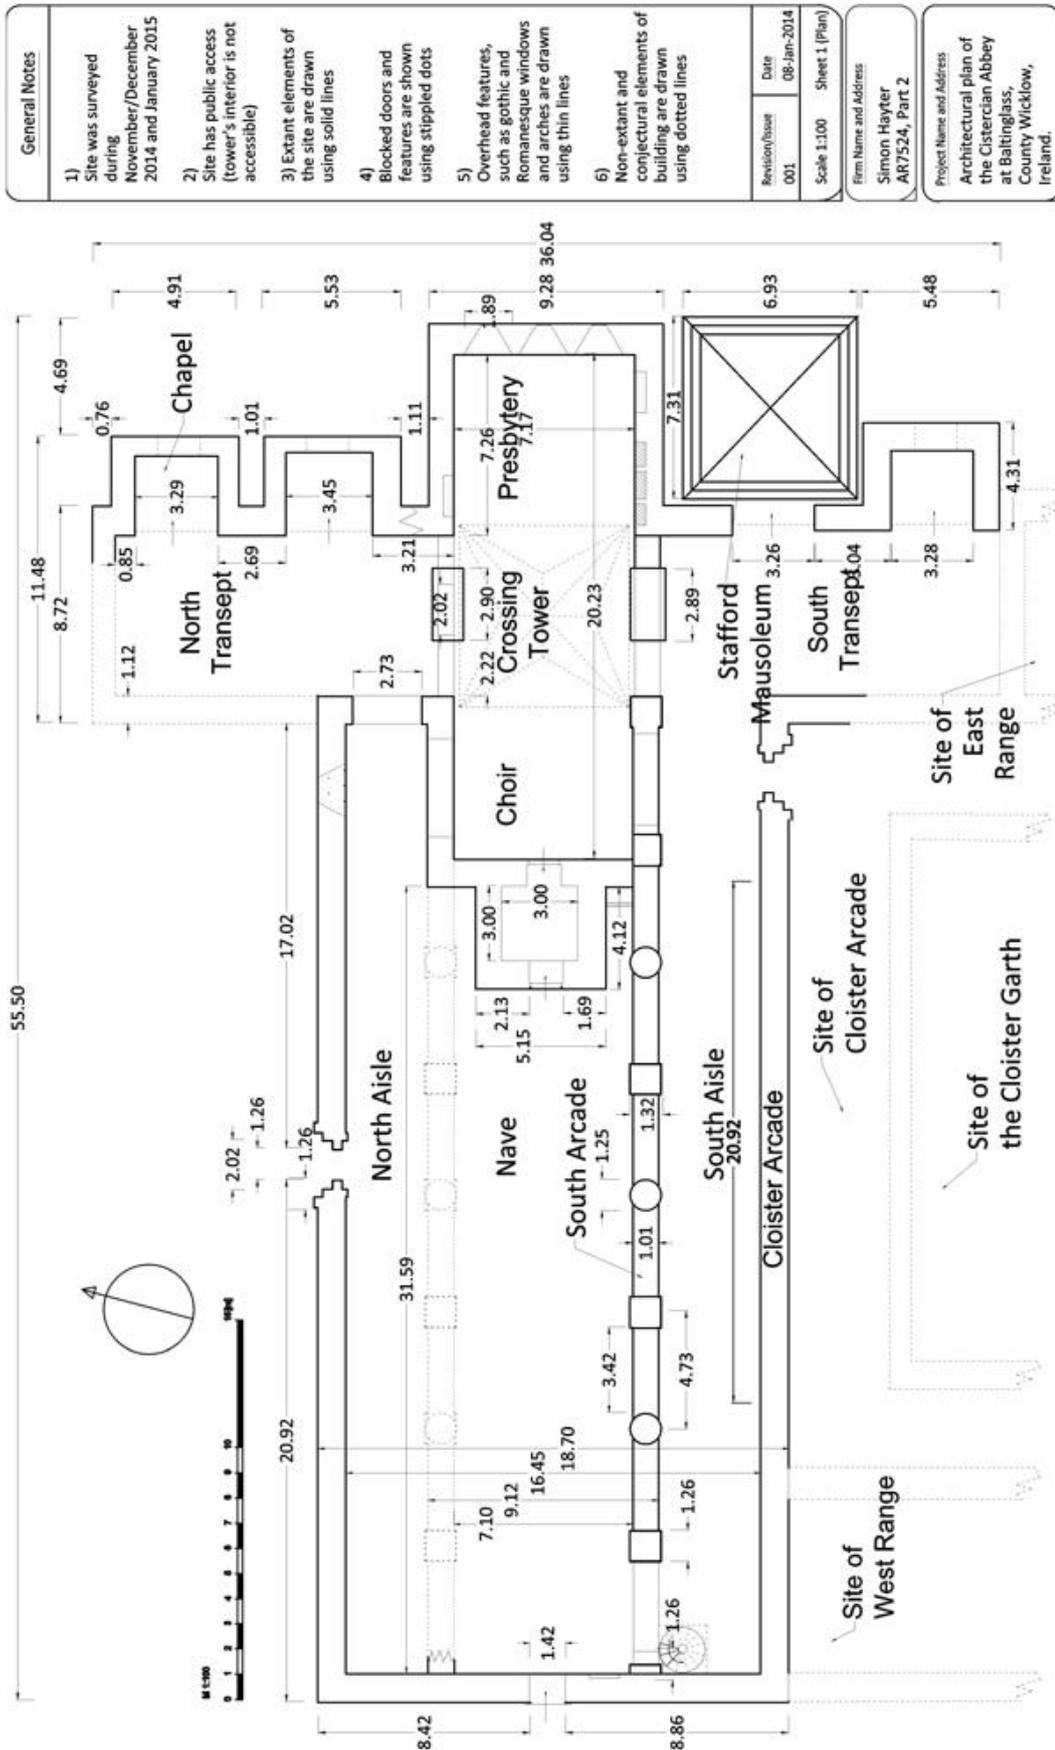
8.5 Appendix V: Architectural Plan

The Architectural Plan, Appendix VI, confirms that the east-west length of the church is 55.5 meters and, the probable north-south width is 36.0 meters. The Architectural Section of the building, Appendix VII, confirms that it is not possible to determine the original height of the church.
